# Manhole Inspection Summary

Manhole # S55G\_\_045MH

Insp Date: **4/18/08 11:34 AM**

**Location** Address: **3723 claremont ave**

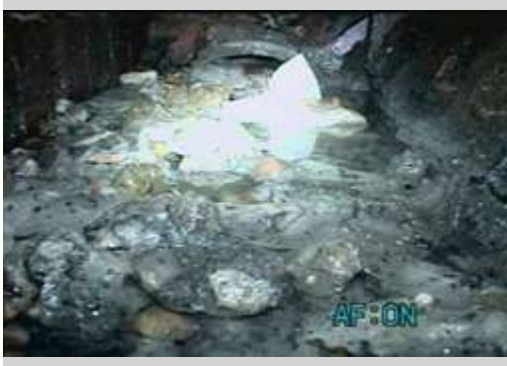
Defect 2

Condition: ☐ Sound ☐ Cracked ☐ Root Intrusion ☐ Deteriorated ☐ Leaks ☒ **Debris**

channel debris

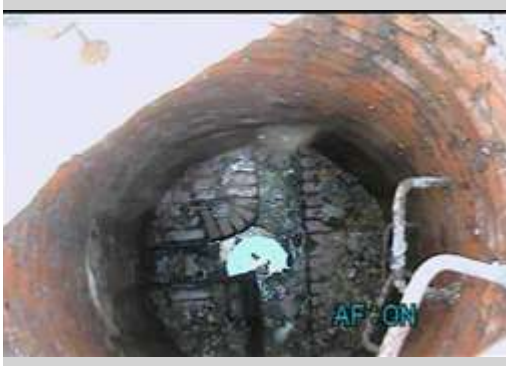
Defect 1

**Steps** Count: **5** Missing: **0** ☒ **Corroded**

steps

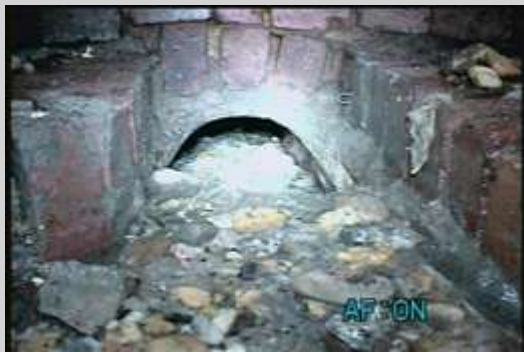
12 O'Clock Outflow

8 in. Circular Gravity Sewer  
Pipe Out @ 12 O'Clock

Deposits: ☐ None ☐ Mud ☐ Sludge ☒ Debris ☐ Grease

Silt Depth: 6 (in.) Deposits Extent: Heavy

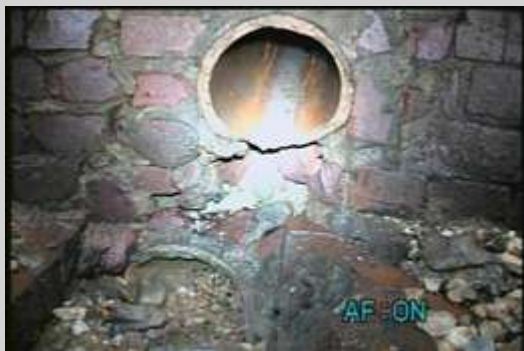
6 O'Clock Inflow

8 in. Circular Gravity Sewer  
Pipe In @ 6 O'Clock

Deposits: ☐ None ☐ Mud ☐ Sludge ☒ Debris ☐ Grease

Silt Depth: 6 (in.) Deposits Extent: Heavy
